Analysis of Ice-Jam Flood Observations in the Recent Years in Lithuania

ICEREG Project – PP3 Role

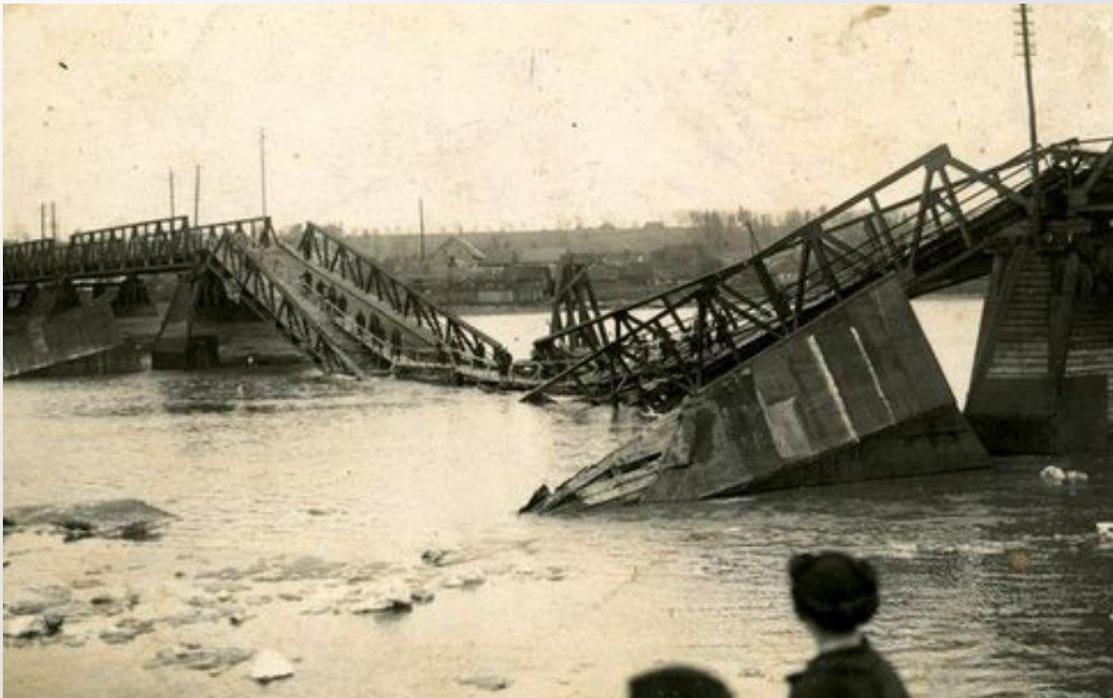
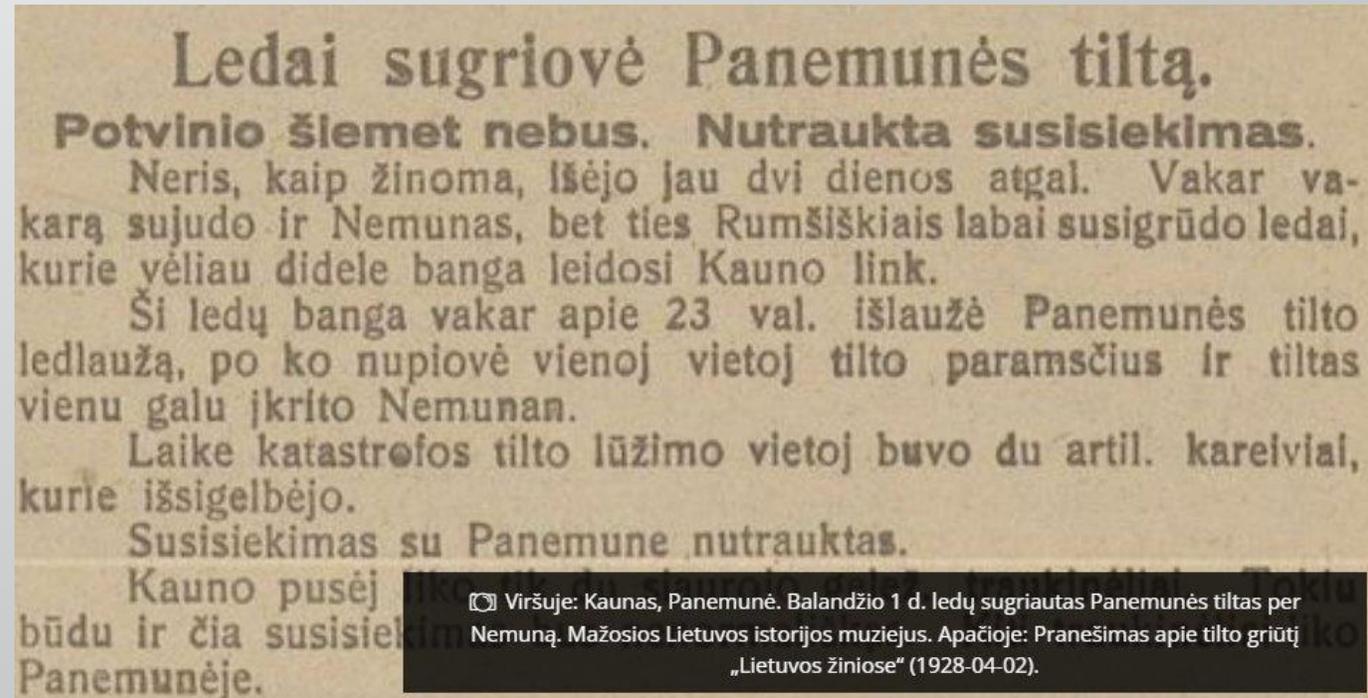
Flood in Kaunas (Panemunė), 1928

The Panemunė Bridge in Kaunas is one of the few bridges where people managed to escape after it collapsed...

On the evening of April 1, 1928, an ice jam knocked down one of the piers of a newly built (still not fully completed) bridge, but fortunately, no one was injured.

"The Neris, as is known, broke up two days ago. Last night, the Nemunas also began to move, but the ice became heavily jammed near Rumšiškės. Later, the ice broke free and surged in a large wave toward Kaunas. Around 11 p.m. yesterday, this wave of ice broke through the icebreaker of the Panemunė bridge, after which it swept away some of the bridge's supports in one section, causing one end of the bridge to collapse into the Nemunas River."

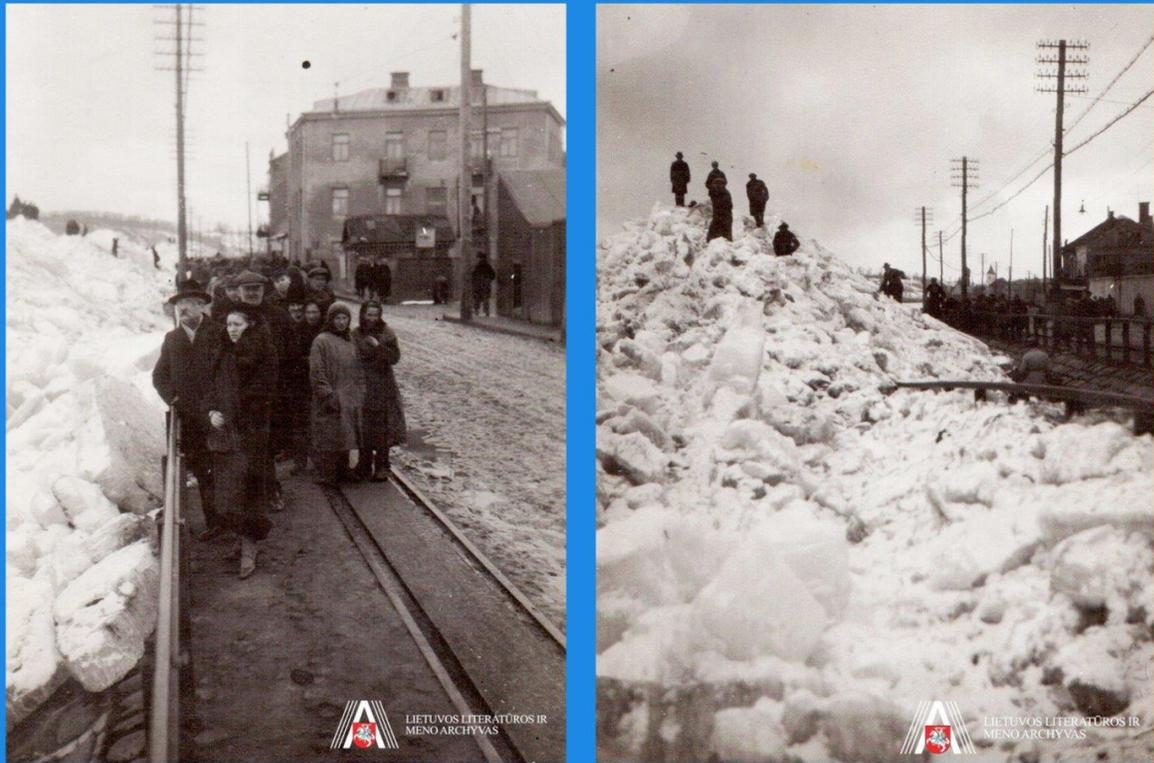
The Great Kaunas Flood of 1946

- "In 1946, there was an exceptionally cold winter. Around the end of February - beginning of March, a thaw occurred and the Nemunas River moved and began to carry ice. However, suddenly frost set in and the ice stopped at Vilkiija. The ice pile here was about 4 km long, and the ice width was about 5 m thick."
- After the flood, the press and advertisements warned that Kaunas residents should not use unboiled water, fearing a humanitarian crisis, which later came to Kaunas. In April, all residents of Kaunas aged 10-45 were to be vaccinated against dysentery and typhoid.

On the late evening of March 23, 1946, the residents of Kaunas noticed that water levels began rising in many parts of the city.

Ice started moving from the Neris River. Early on the morning of March 24, the ice jammed at the confluence of the Nemunas and Neris rivers, and having nowhere to flow, the Neris turned towards Vilijampolė, quickly flooding residents' homes.

On the morning of March 25, the water level at the Kaunas Old Town water measurement station reached the highest in recorded history – as much as 8.57 meters.

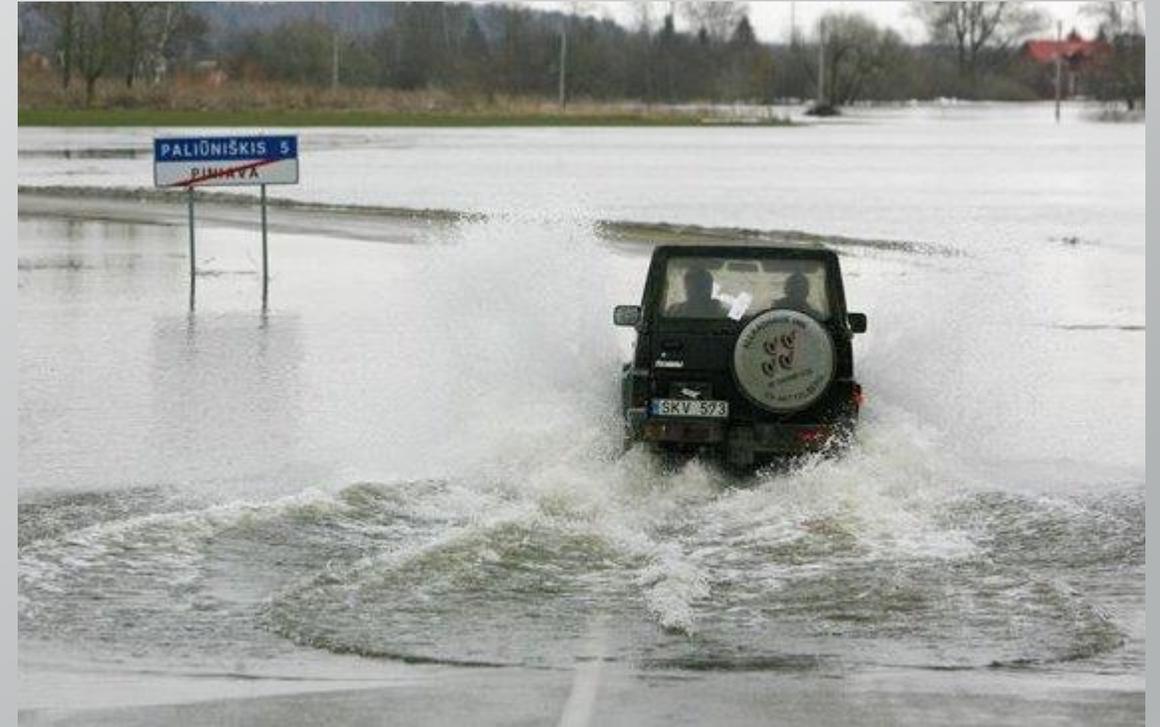
Flood in Panevėžys, photo of Andrius Repšys.

In the year 2010 there was a significant flood in Lėvuo. There was a large ice-jam near Piniava village. On 23 March, the water level was rising up 126 cm above critical level and reached 46,67 m a.s.l. (perennial highest water level 46,73 m a.s.l.).

Community gardens and roads were flooded. Houses in Tičkūnai and Šeškai villages were also flooded, several families were evacuated, electricity was turned off in 7 community gardens, and the "Kemira GrowHow" seed factory was flooded. The water broke through the embankment at Pakuodžiupiai village, flooded the fields from Bernatoniai village towards the Pušalotas town and started to flood Skaistgiriai villages.

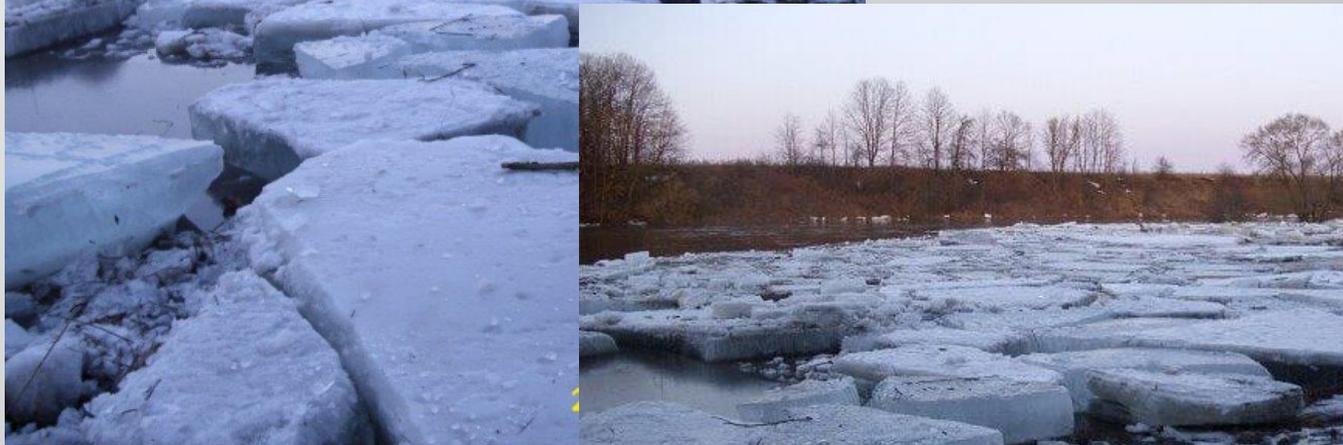
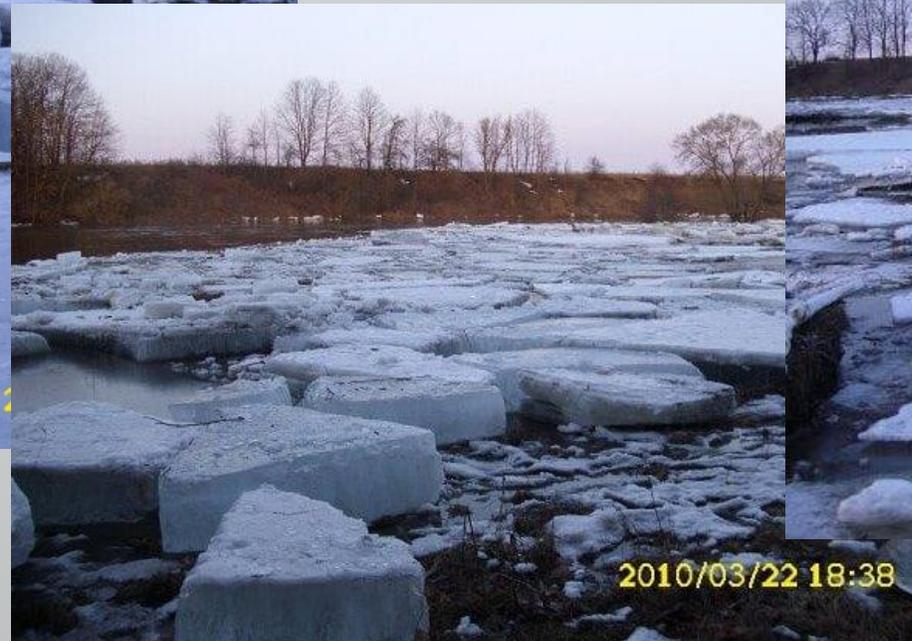
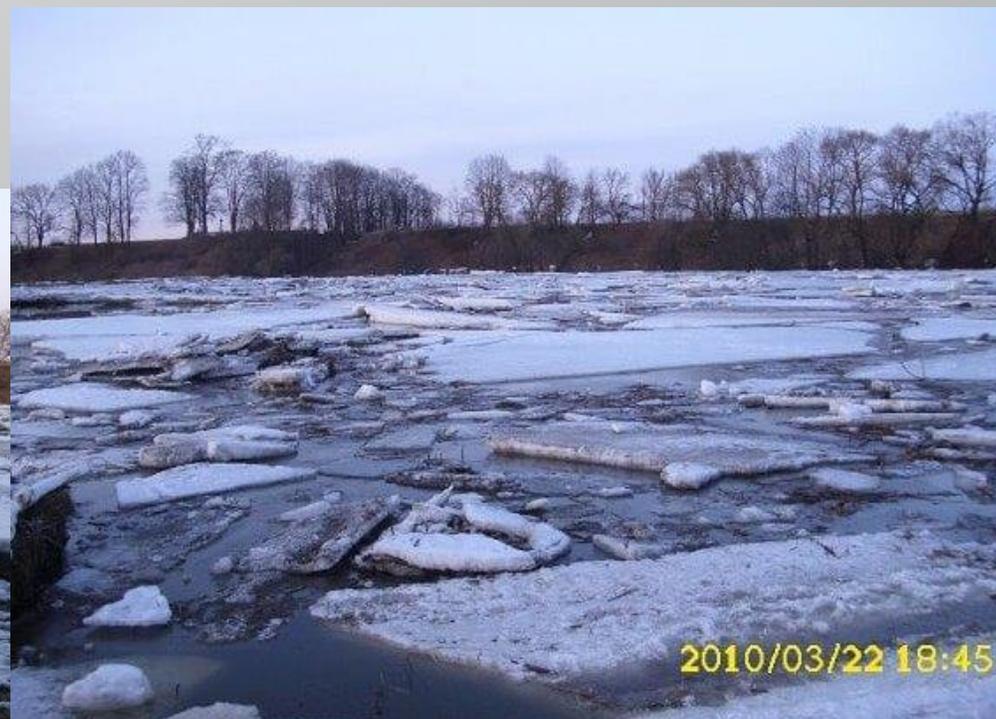
Mūša-Ledonešis-Narteikiai. Jono Vitkausko nuotr.

In the spring of 2010, due to ice jams, the maximum water level in Musa near Ustukiai reached 30.25 m a.s.l. (90 cm above critical level).

Ice-jam flood in 2010 caused some damage, flooding of floodplains at a river stretch.

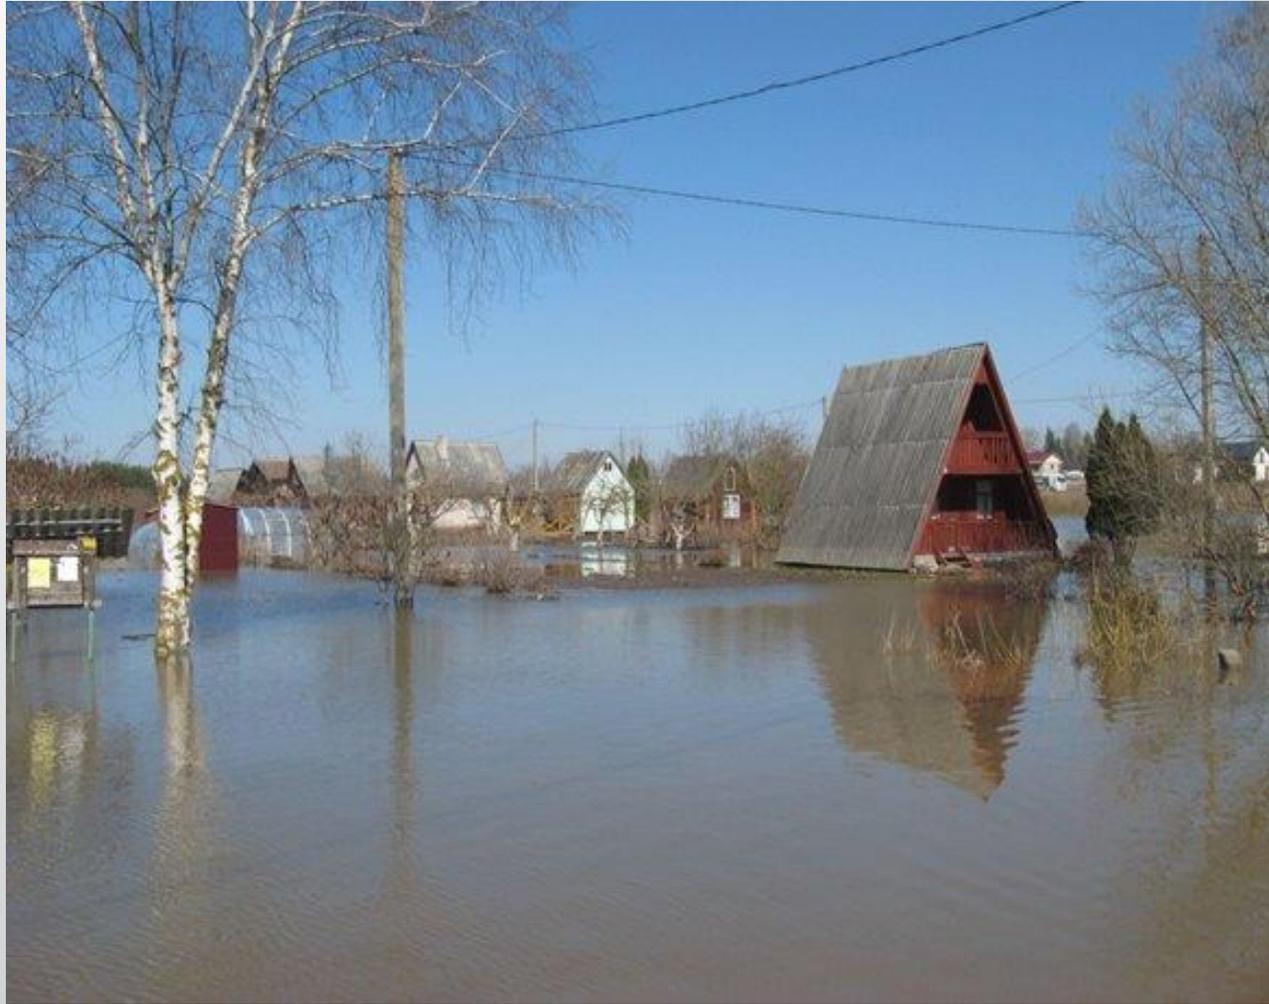
Flooded community garden "Vyturys", April, 2013

In April 2013, ice jams caused extensive flooding in Musa River.

At Ustukiai water level reached 30.51 m a.s.l. (125 cm above critical level).

Ice-jam flood in 2013 cause a lot of damage in Pasvalys town, where houses, warehouses, summerhouses, greenhouses were flooded. The water layer up to 0.5-1 m deep covered Žemdirbių and Bokšto streets in the community garden "Vyturys". However, residents refused to evacuate.

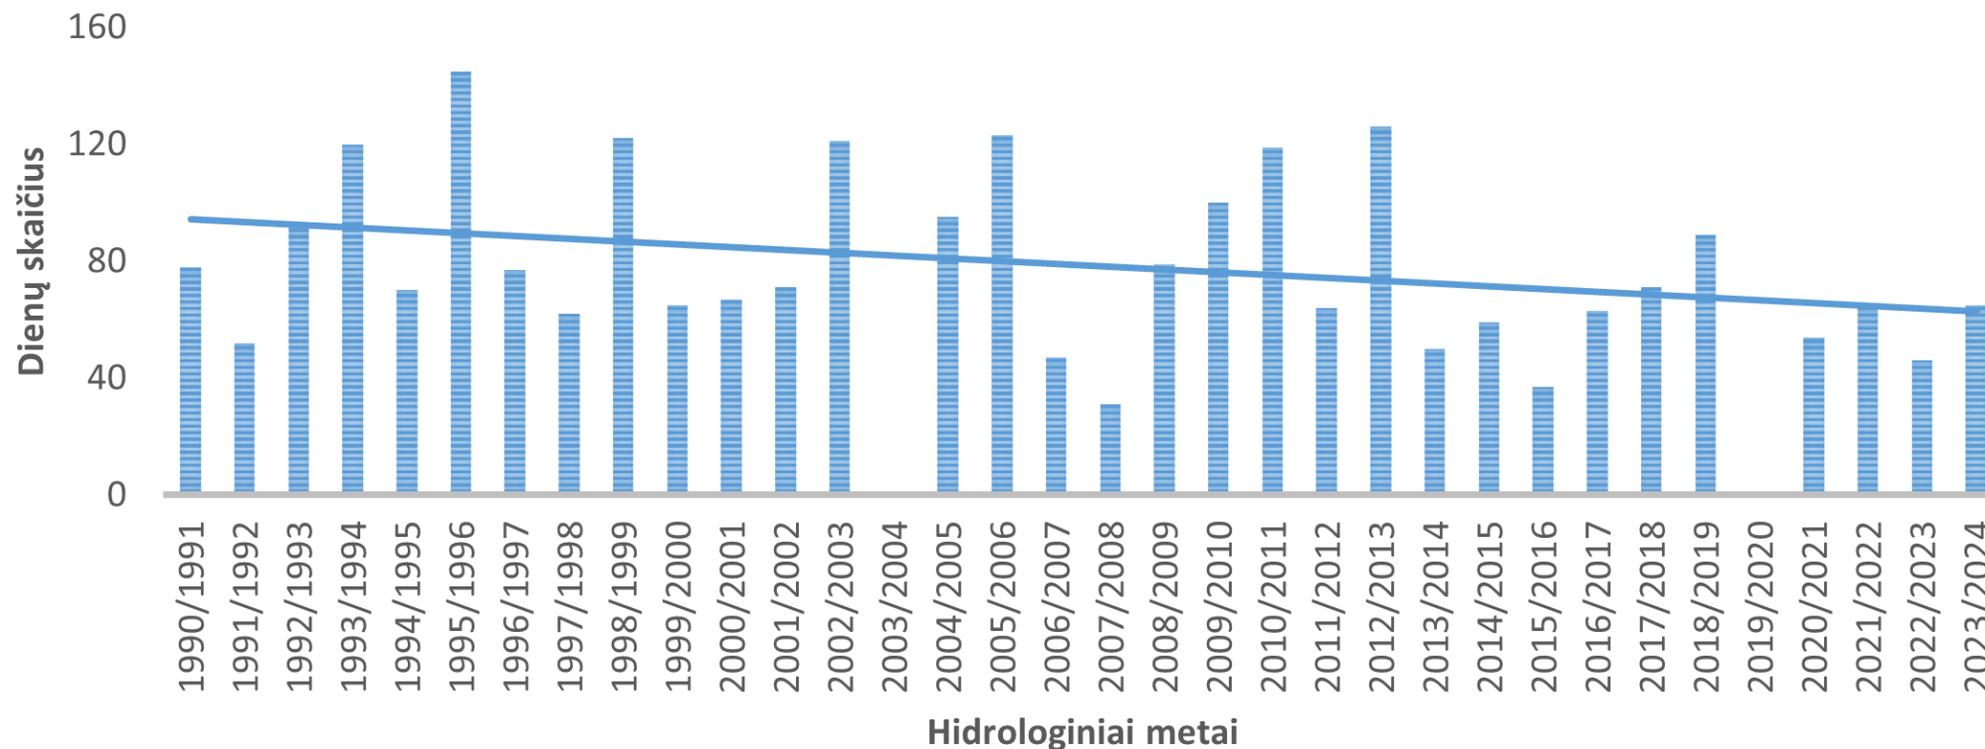
The Tendency of Ice Phenomena in the Mūša River in Ustukiai, 1990 - 2020

DIENOS SU LEDO REIŠKINIAIS MŪŠOJE TIES USTUKIAIS, 1990-2024 M.

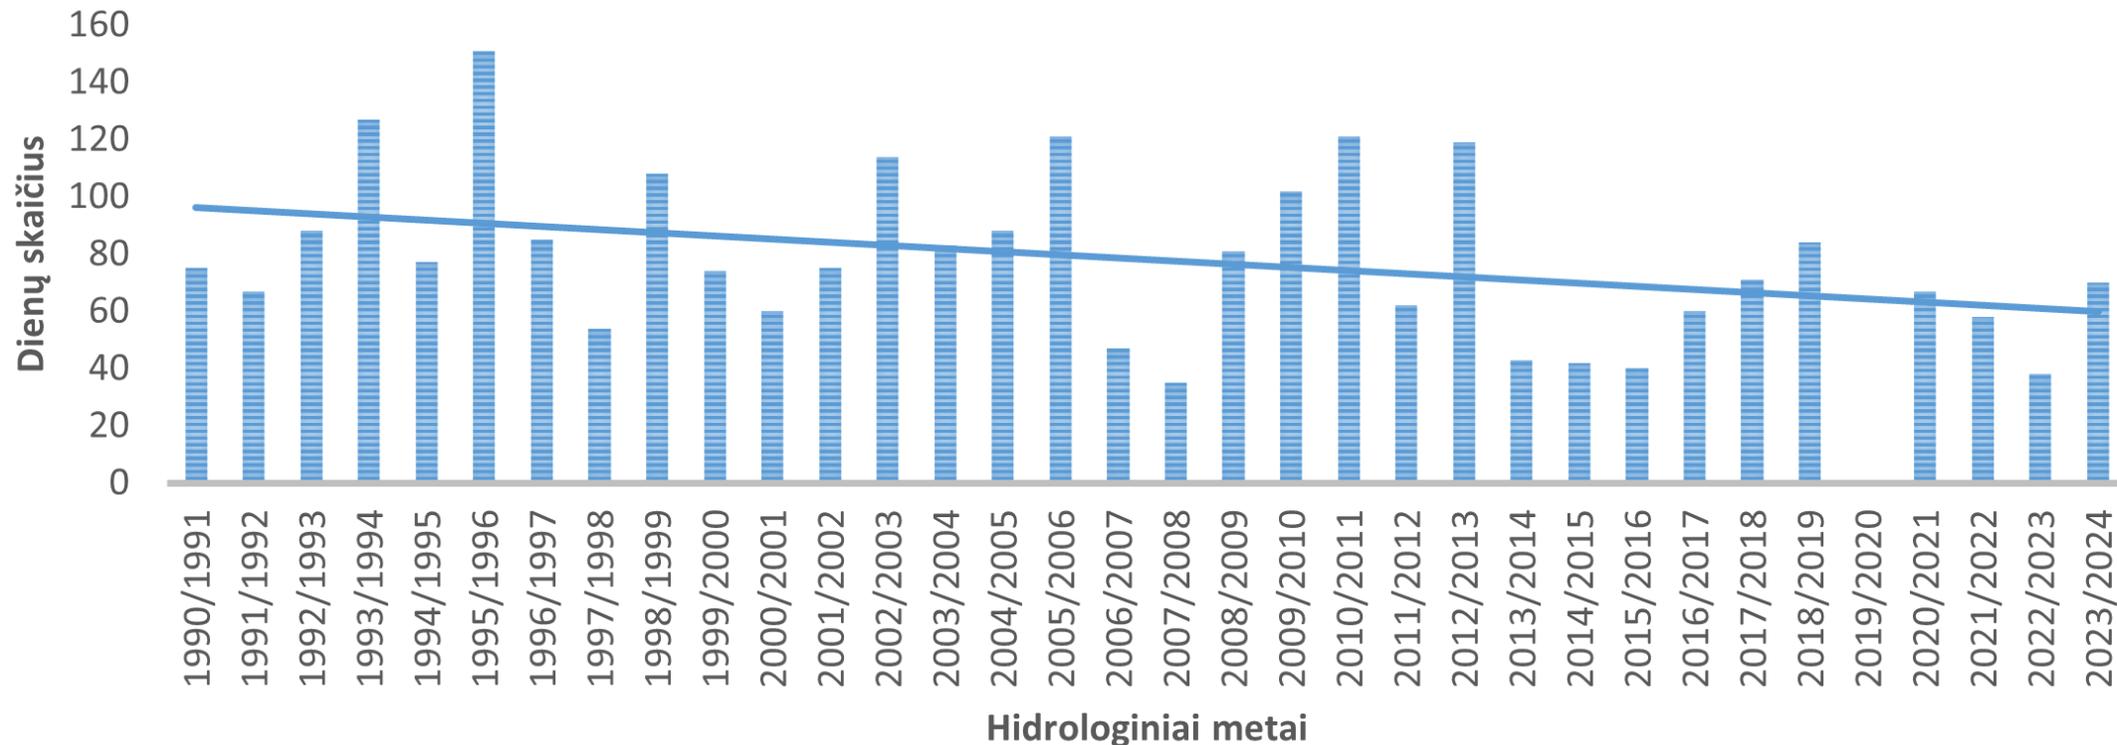
The Tendency of Ice Phenomena in the Lėvuo River in Bernatoniai, 1990 - 2024

DIENOS SU LEDO REIŠKINIAIS LĖVENYJE TIES BERNATONIAIS, 1990-2024 M.
